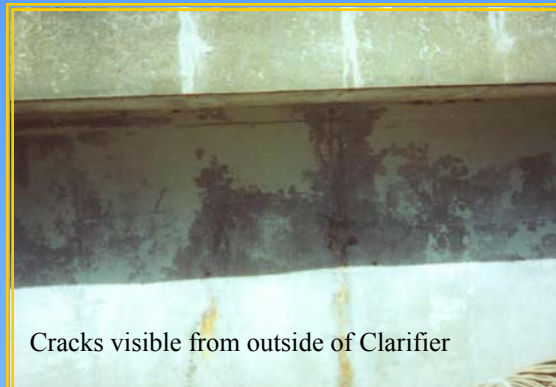
Cracks visible from outside of Clarifier
